STATE OF MONTANA  
NATURAL RESOURCE DAMAGE PROGRAM

GROUNDWATER RESOURCES  
INJURY ASSESSMENT REPORTS

UPPER CLARK FORK RIVER BASIN

**GROUNDWATER INJURY ASSESSMENT REPORTS**

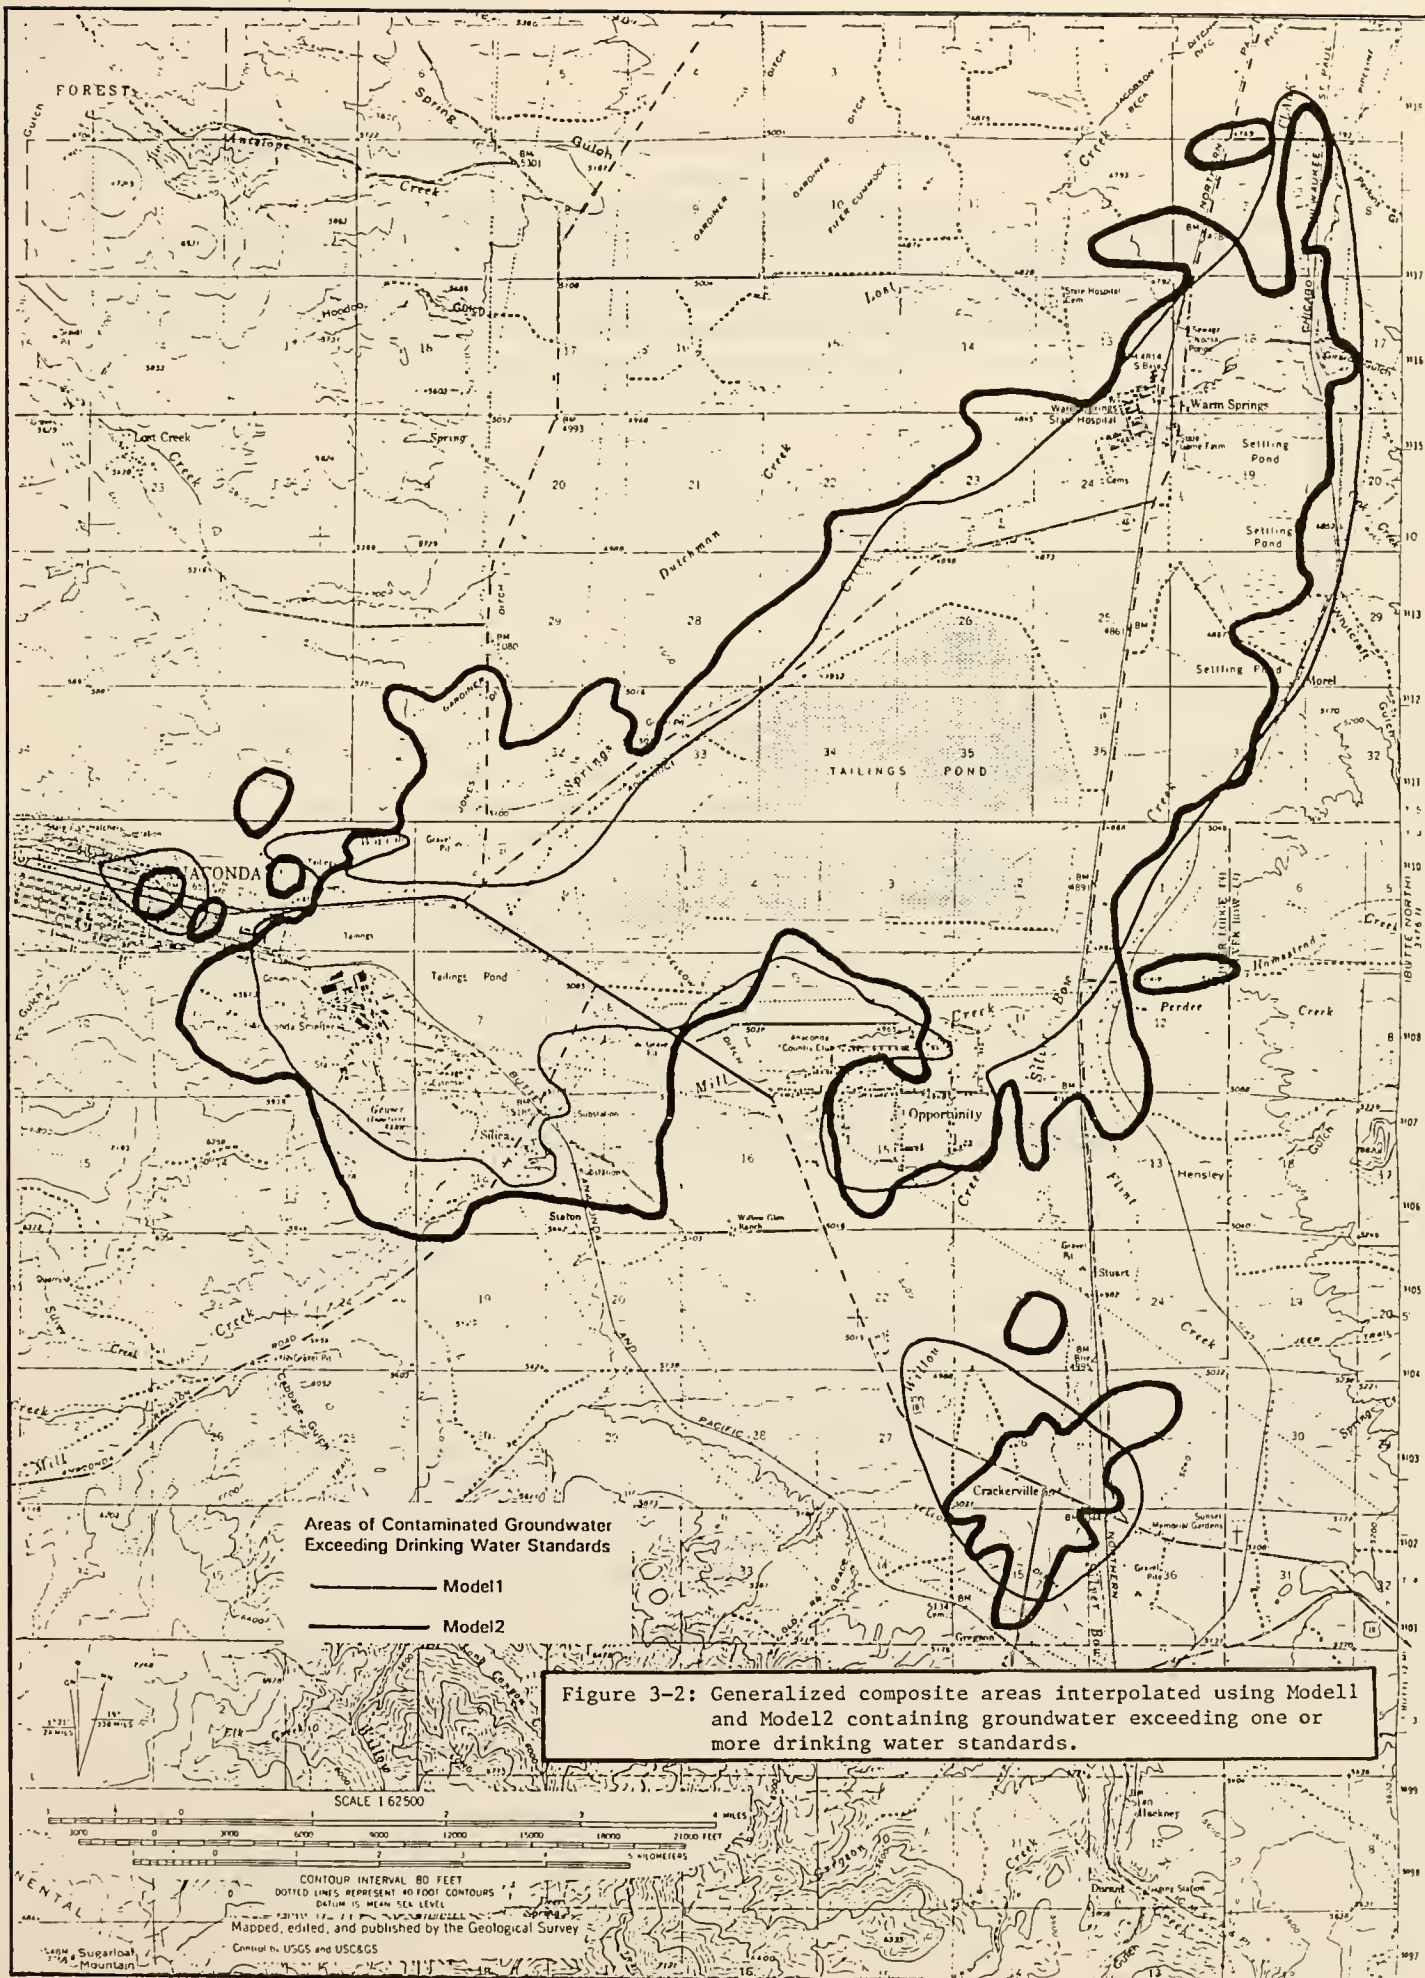
The composite discharge of groundwater contaminated with hazardous substances and other wastes ranges between 8,000 and 9,000 acre feet/year in the vicinity of Opportunity Ponds and is estimated to be about 1,100 acre-feet/year at Warm Springs Ponds.

Figure 3-2: Generalized composite areas interpolated using Model1 and Model2 containing groundwater exceeding one or more drinking water standards.

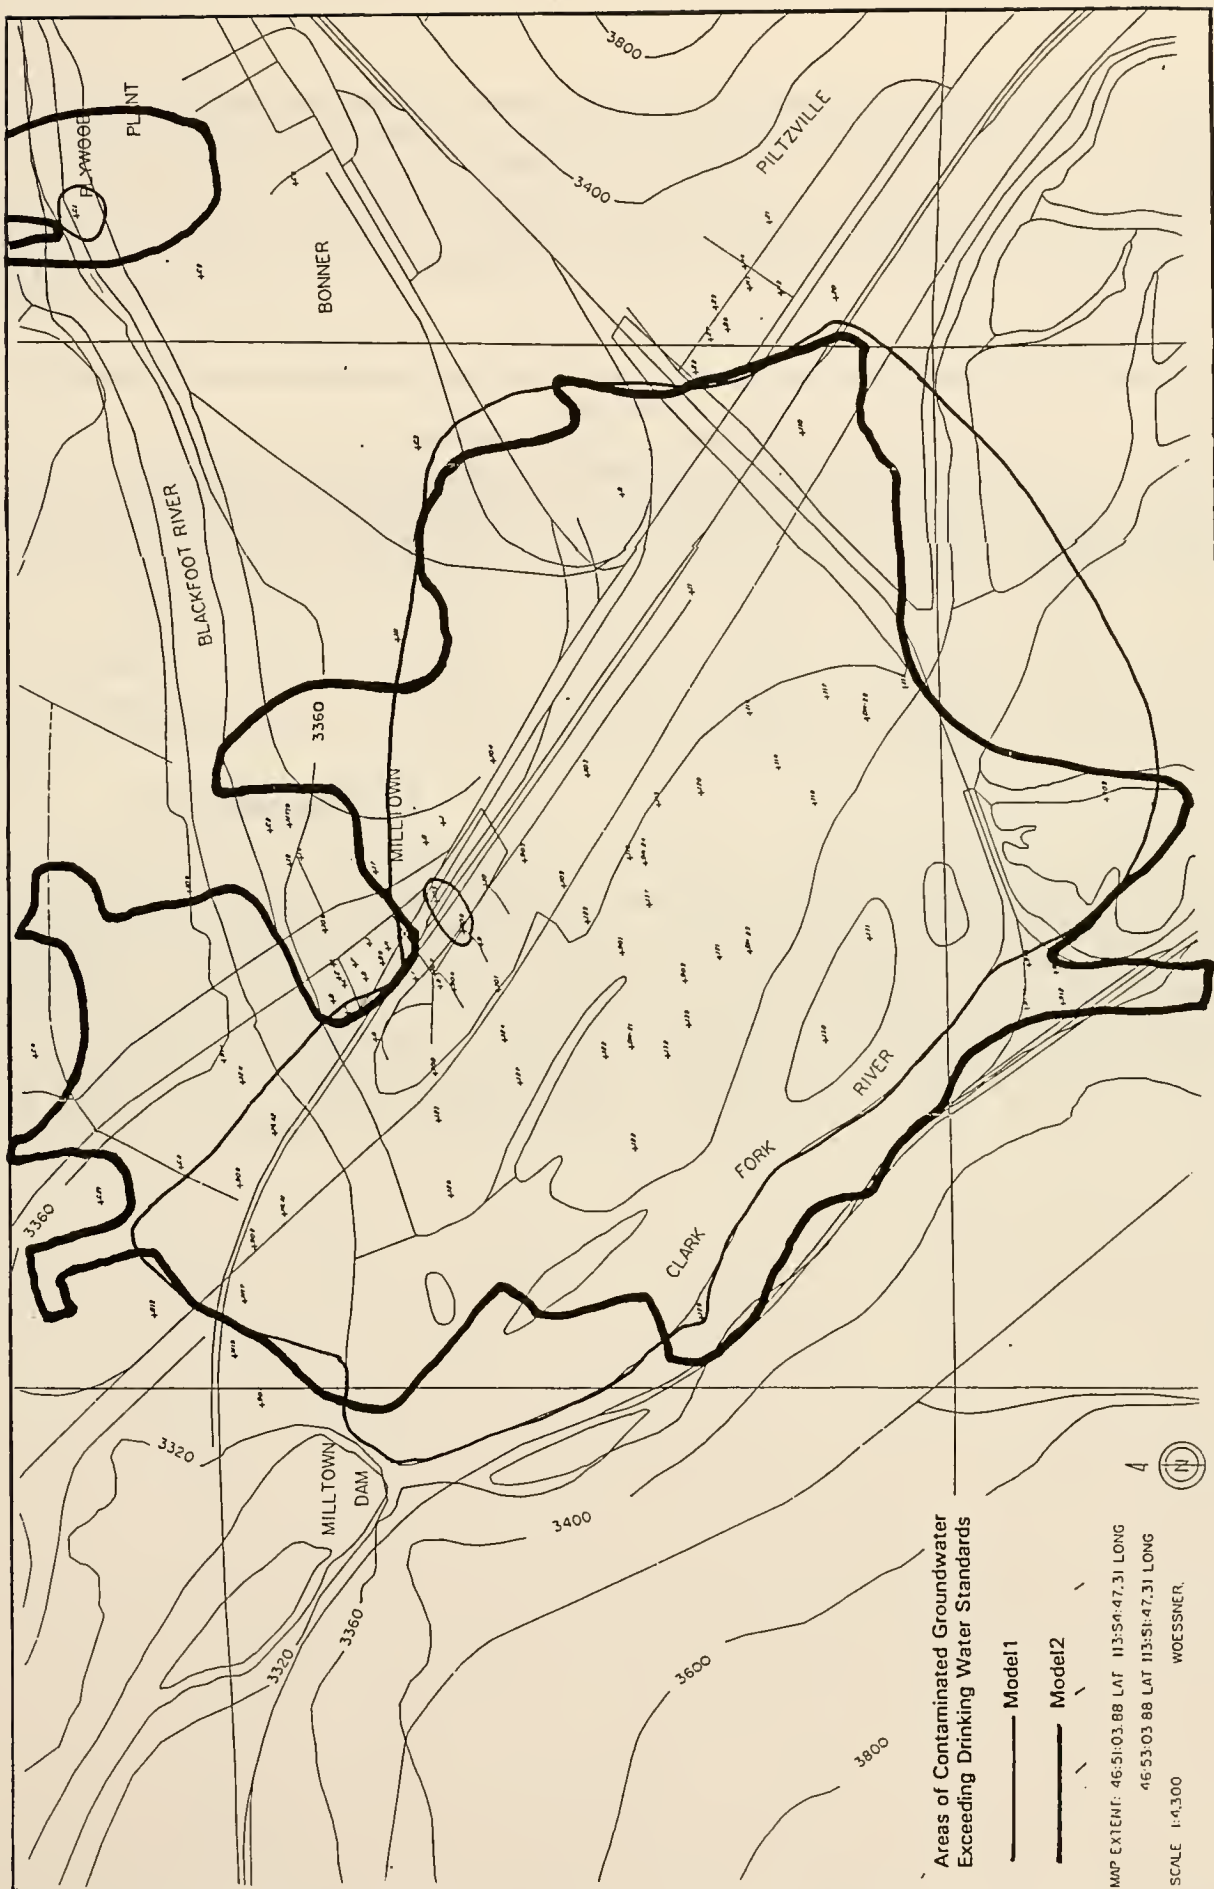
Table 4-2 Summary of Volumes Flux of Injured Groundwater in Milltown		
Substance	Volume (Acre-feet)	Flux (Acre-feet/year)
Arsenic	2140	27,000
Iron	3108	50,400
Manganese	4410	117,100

Figure 4-2: Generalized areas interpolated using Model1 and Model2 containing groundwater exceeding drinking water standards for dissolved manganese, 50ug/l.

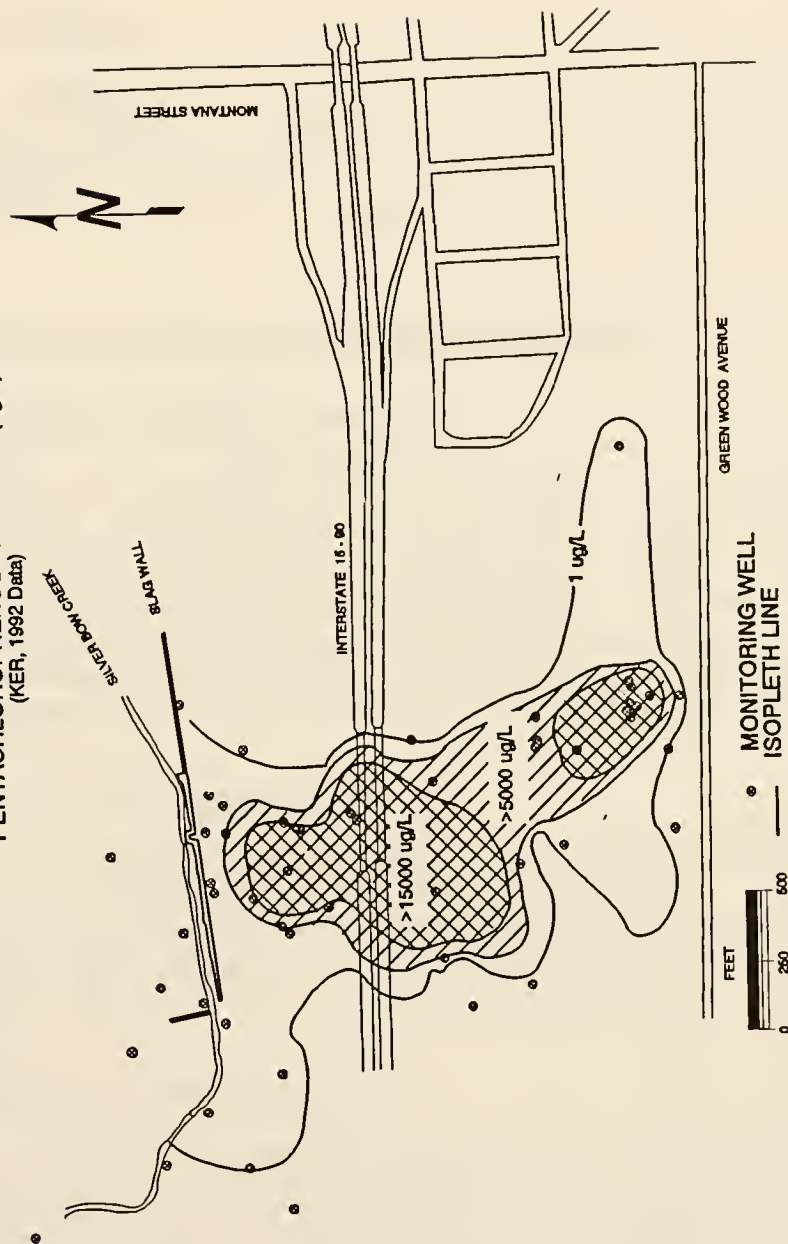
Figure 5-2.

The vertical extent of contamination was based on PCP concentrations from wells completed at depth. Using an average depth to water of 12 feet and an average depth to bedrock of 35 feet, the saturated thickness was estimated to be 23 feet. Using this thickness the 44 acre area of the 1 ppb isopleth, and an estimated porosity of 32%, the total volume of injured groundwater is approximately 350 acre-feet.

# **MONTANA POLE TREATMENT SITE** **PENTACHLOROPHENOL ISOPLETH (ug/L)** (KER, 1992 Data)
